DEPARTMENT OF TRANSPORTATION

Quality Assurance and Source Inspection

Contract #: 04-0120F4Cty: SF/ALA Rte: 80 PM: 13.2/13.9File #: 69.28**WELDING INSPECTION REPORT****Resident Engineer:**Siegenthaler, Peter**Address:** 333 Burma Road**City:** Oakland, CA 94607**Report No:** WIR-017855**Date Inspected:** 08-Oct-2010**Project Name:** SAS Superstructure**OSM Arrival Time:** 700**Prime Contractor:** American Bridge/Fluor Enterprises, a JV**OSM Departure Time:** 1900**Contractor:** Zhenhua Port Machinery Company, Ltd (ZPMC), Changxing Island **Location:** Shanghai, China**CWI Name:** Liu Hua Jie**CWI Present:** Yes No**Inspected CWI report:** Yes No N/A**Rod Oven in Use:** Yes No N/A**Electrode to specification:** Yes No N/A**Weld Procedures Followed:** Yes No N/A**Qualified Welders:** Yes No N/A**Verified Joint Fit-up:** Yes No N/A**Approved Drawings:** Yes No N/A**Approved WPS:** Yes No N/A**Delayed / Cancelled:** Yes No N/A**Bridge No:** 34-0006**Component:** Orthotropic Box Girder(OBG)**Summary of Items Observed:**

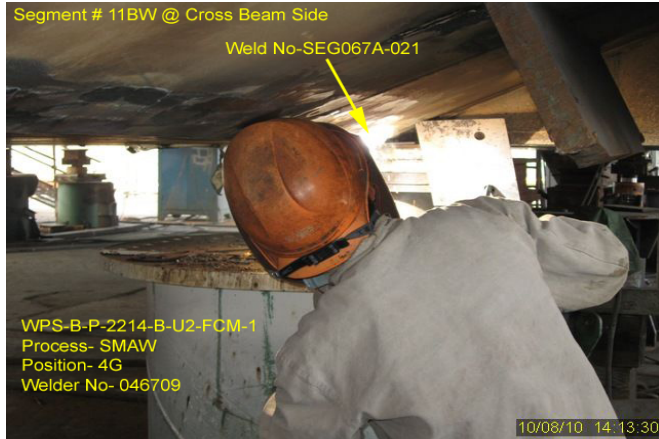
This QA inspector observed ZPMC qualified welding personnel identified as 046709 perform Shielded Metal Arc Welding (SMAW), weld joint identified as SEG067A-021; located On Orthotropic Box Girder (OBG) Bottom Plate to Side Plate. ZPMC Quality Control (QC) is identified as Mr. Wang Zhu. The welding variables recorded by QC appeared to comply with the Applicable WPS-B-P-2214-B-U2-FCM-1 See the attached Photo

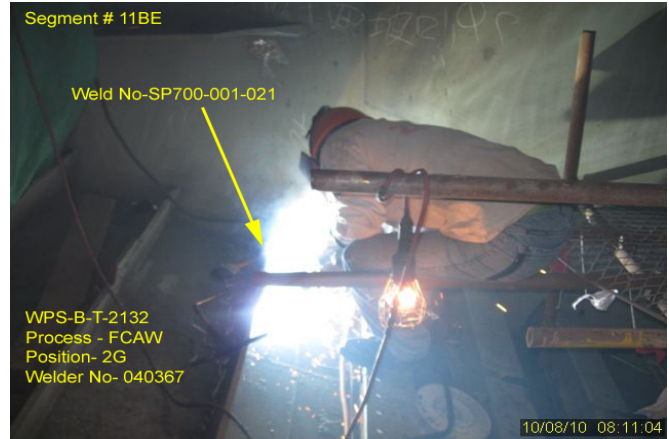
This QA inspector observed ZPMC qualified welding personnel identified as 040367 perform Shielded Metal Arc Welding (SMAW), weld joint identified as SP700-001-021; located On Orthotropic Box Girder (OBG) Corner Assembly Side Plate to I-Rib Hold Back Joint. ZPMC Quality Control (QC) is identified as Mr. Wang Li Yang.

The welding variables recorded by QC appeared to comply with the Applicable WPS-B-T-2132. See the attached Photo.
